Effect of Deicing and Anti-Icing Chemicals on HMA Airfield Runways

D. Christensen, E. Kalberer,
J. Mallela, D. Hein, M.
Farrar, and R. Bonaquist
2010 P3 Symposium

Advanced Asphalt Technologies, LLC

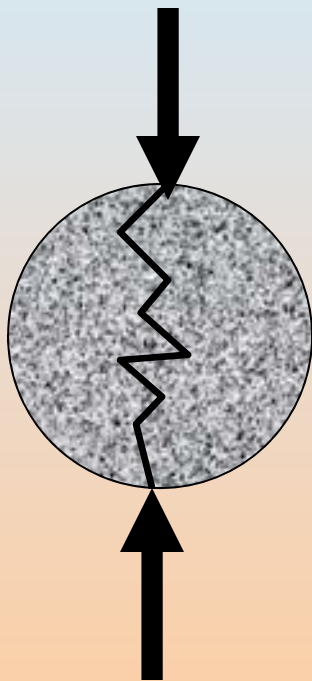
Immersion/Tension (IT) Test

- Similar to AASHTO T 283
- Gyrotory specimens/cores
- No vacuum saturation
- 4 days in 2 % DIAIC solution at 60 C
- Control: 4 days water at 60 C
- Tensile strength ratio

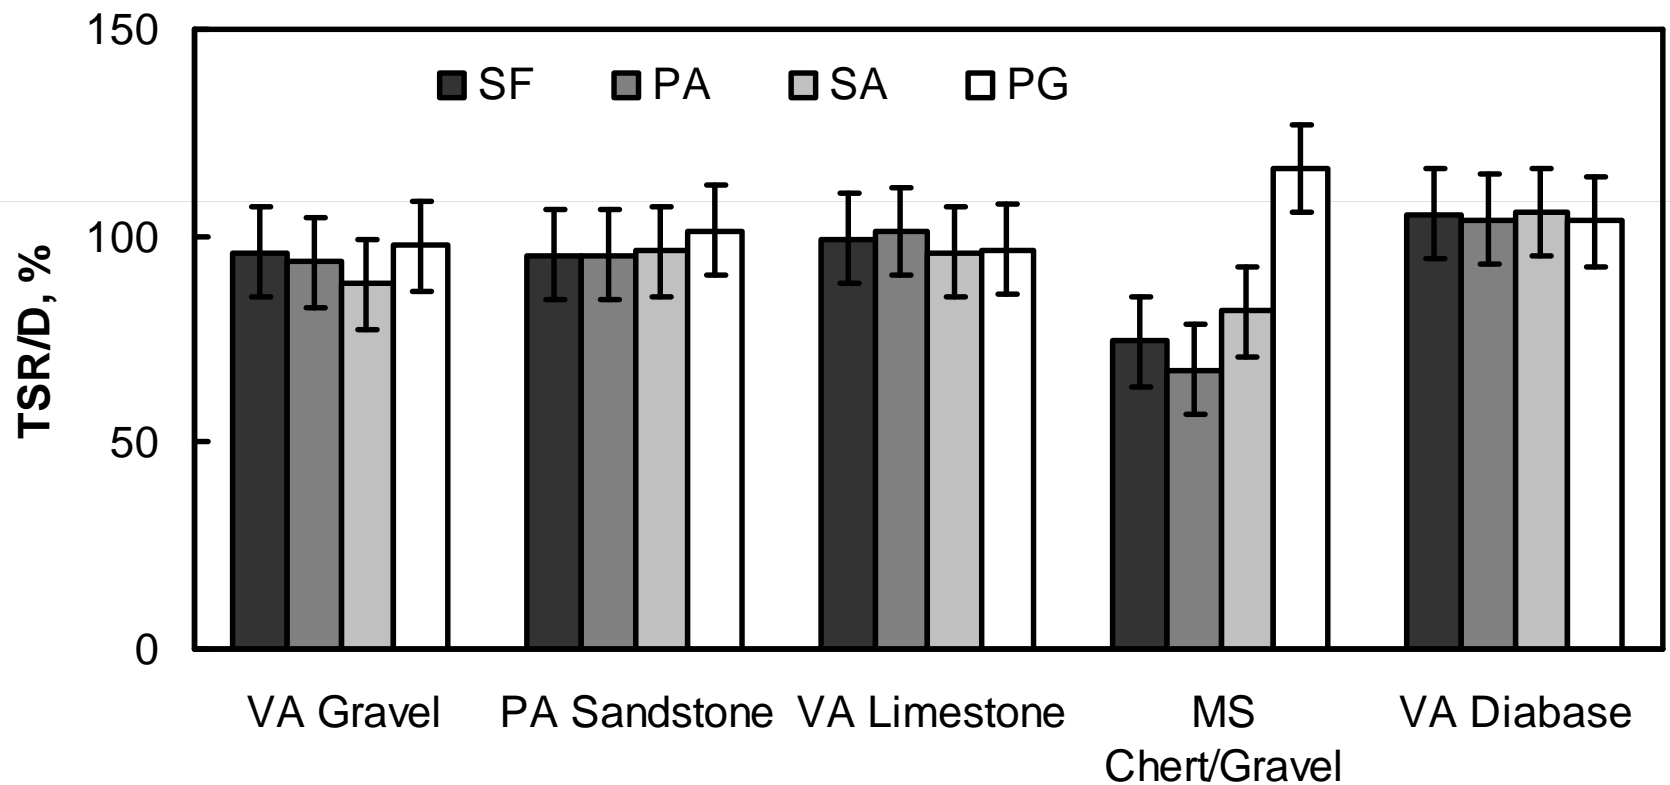
Aggregate Effects Experiment

The PA sandstone and MS chert/gravel are highly AS reactive

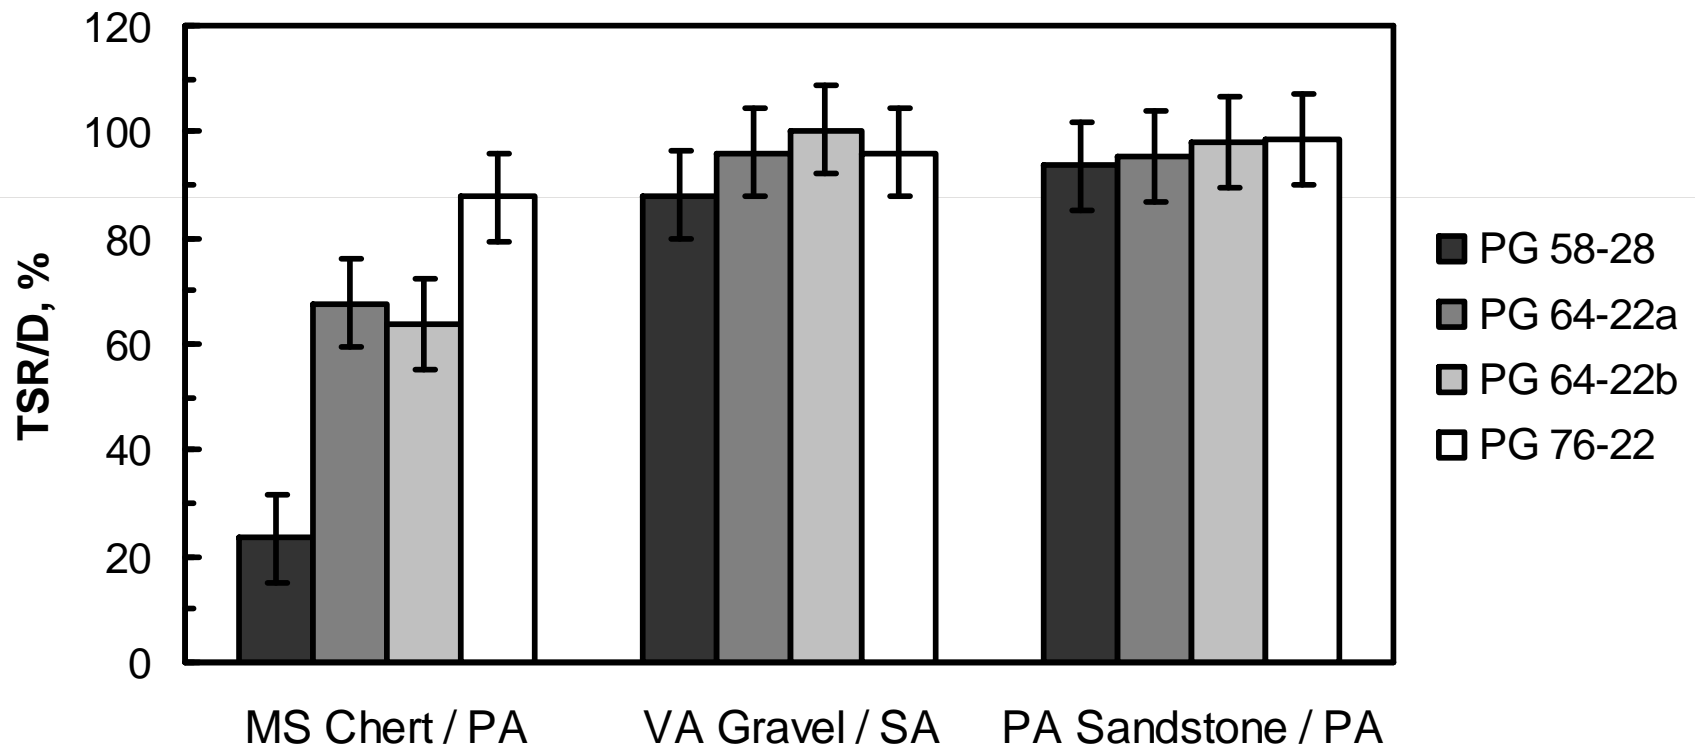
Binder Effects Experiment

This confirmed that softer binders are more susceptible to DIAIC-related damage.

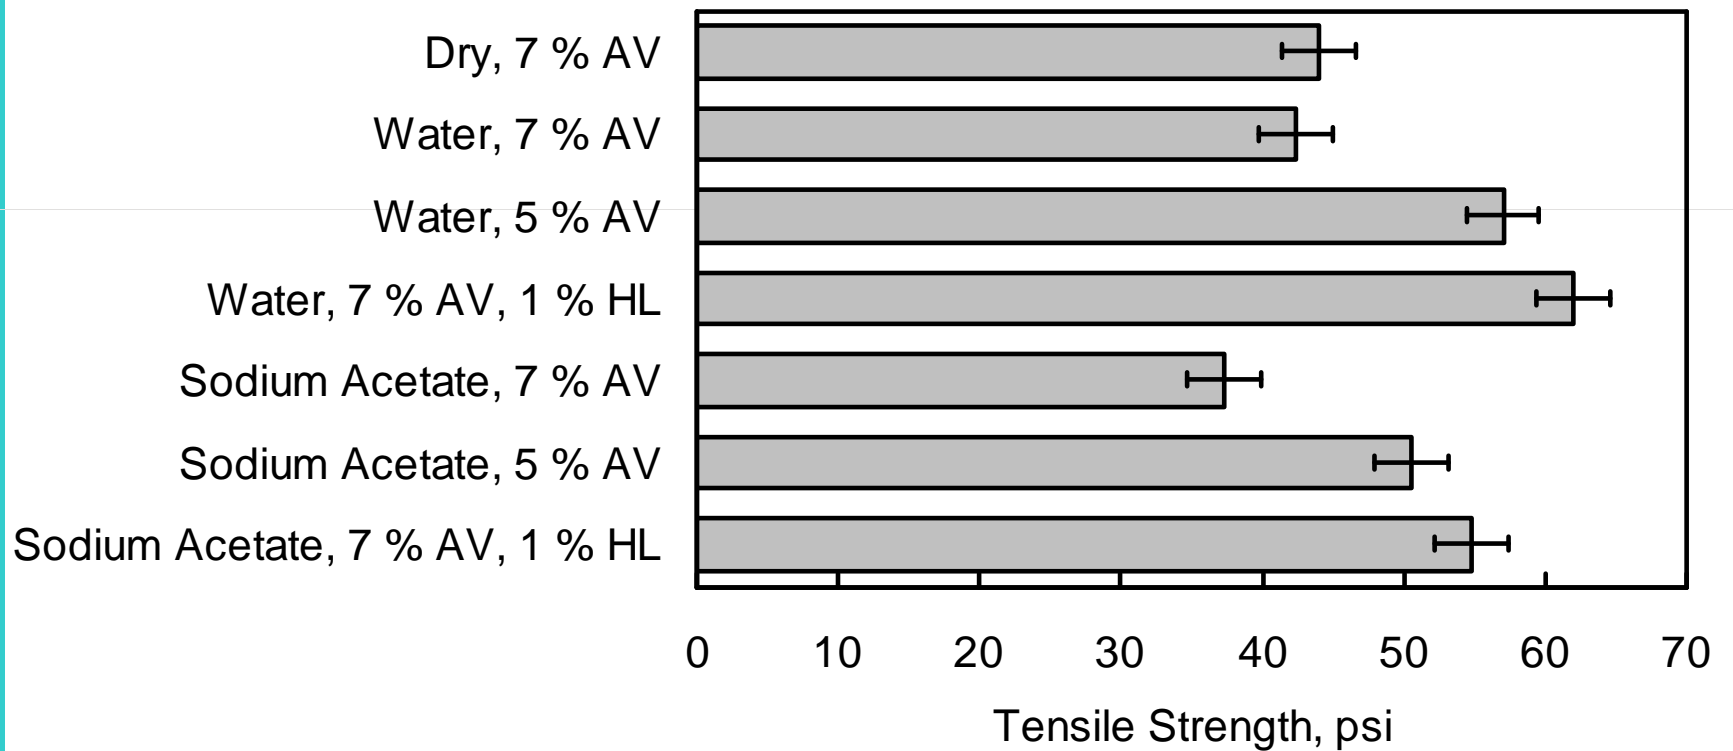
Air Voids/Hydrated Lime Expt.: Virginia Gravel/PG 64-22

There is possibly some slight DIAIC damage at 7 % air voids

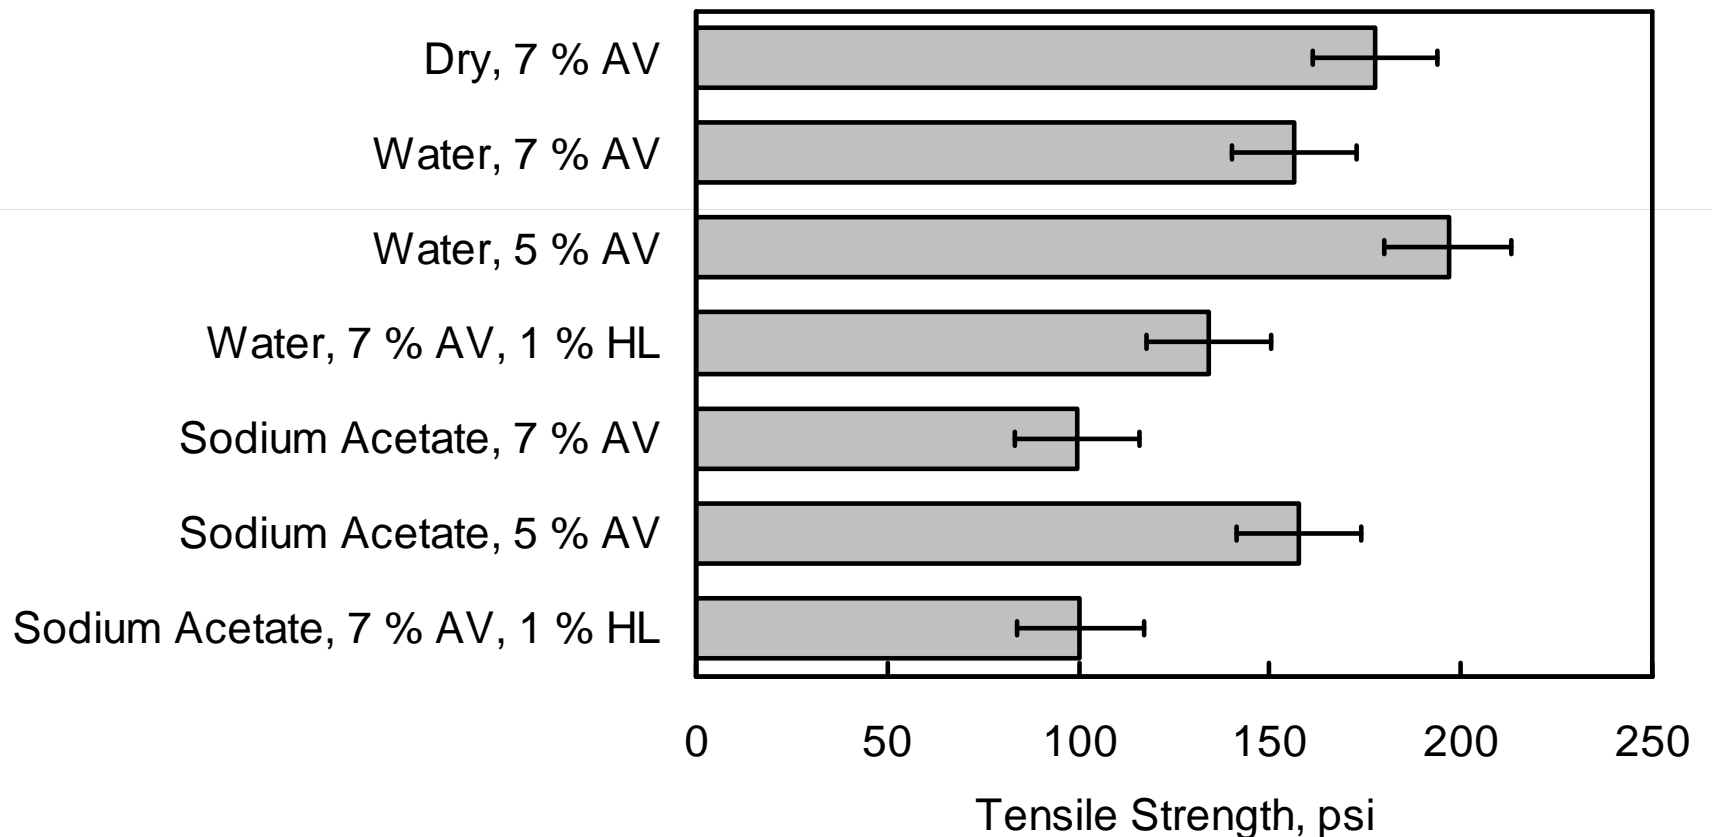
Air Voids/Hydrated Lime Effects: Mississippi Chert/PG 64-22

Lower air voids reduce DIAIC-related damage

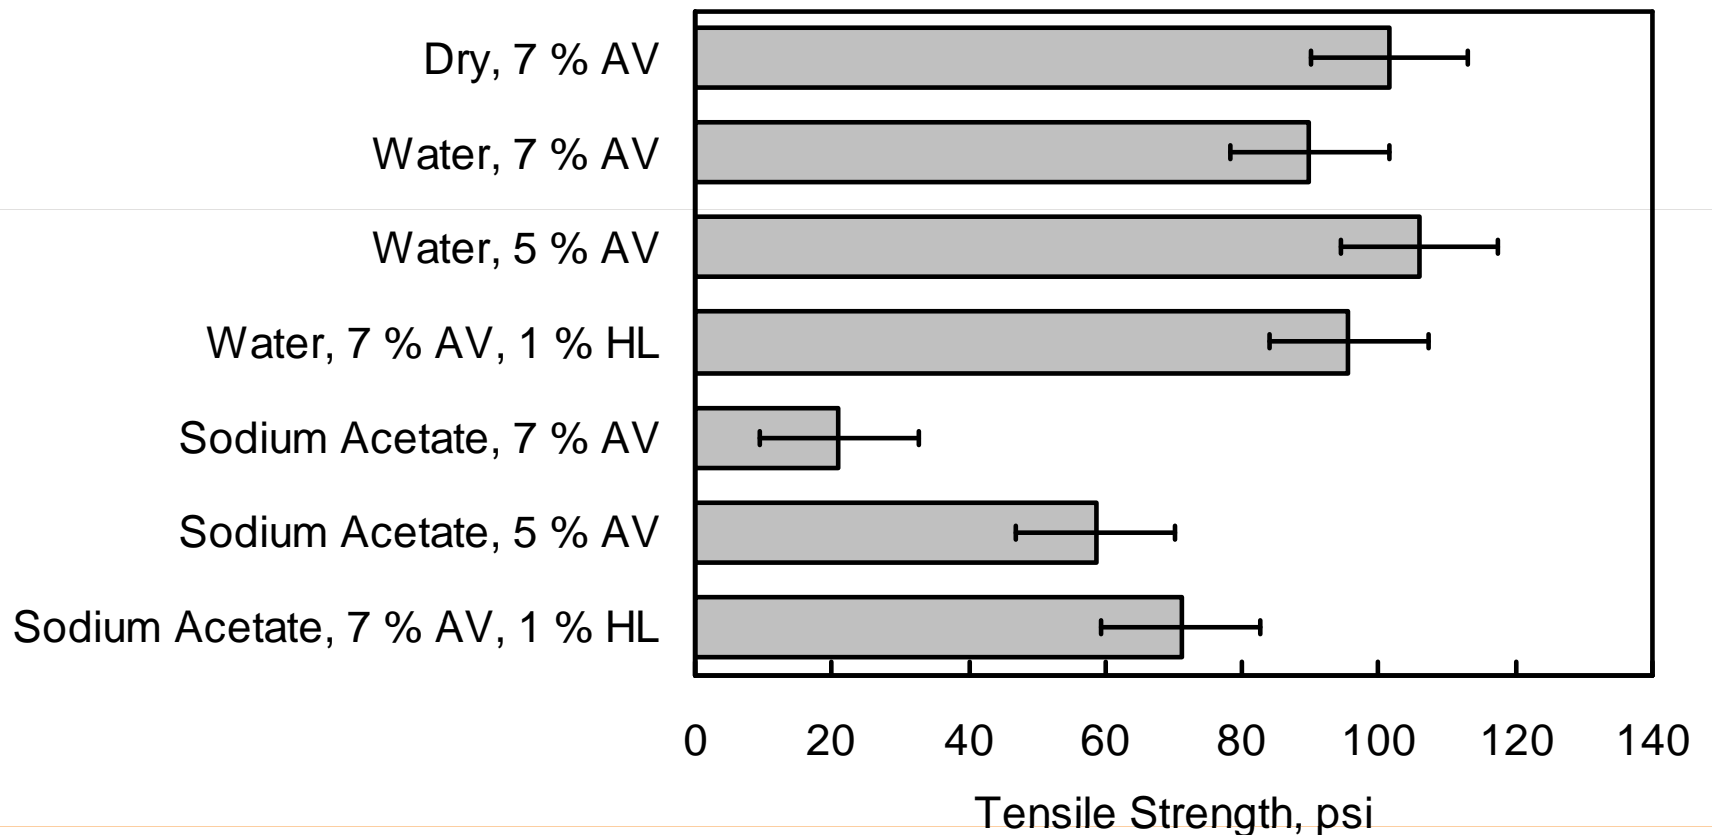
Air Voids/Hydrated Lime Expt.: Mississippi Chert/PG 58-28

In this case, HL also seems to reduce damage

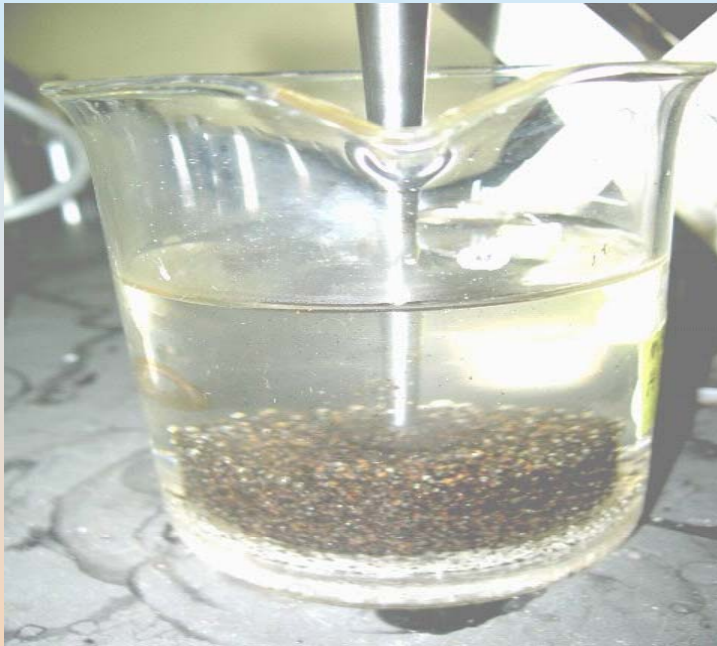
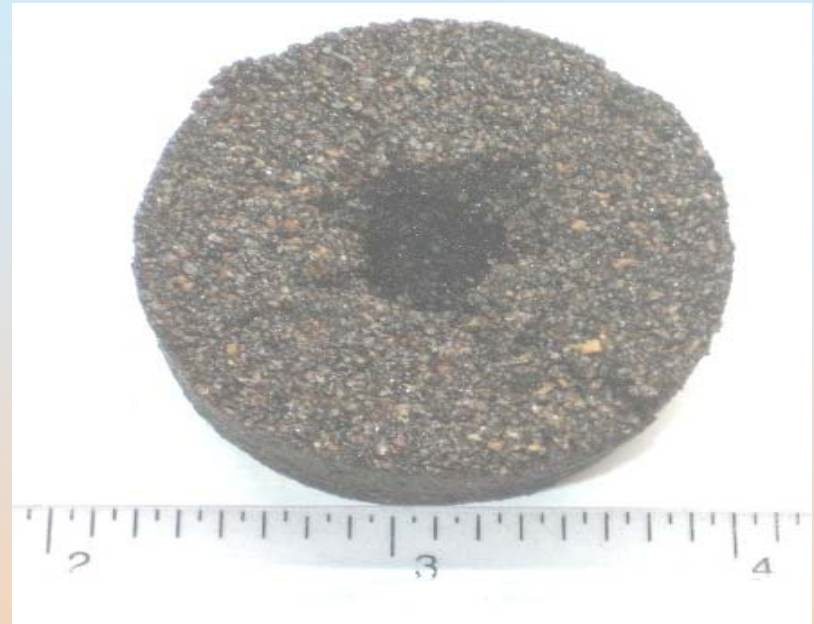
Initial Moisture Damage Results

- 20 kHz, 500 watt ultrasonic horn
- -20/+35 range sieved aggregate
- 2% Aq solutions of KOAc, NaOf

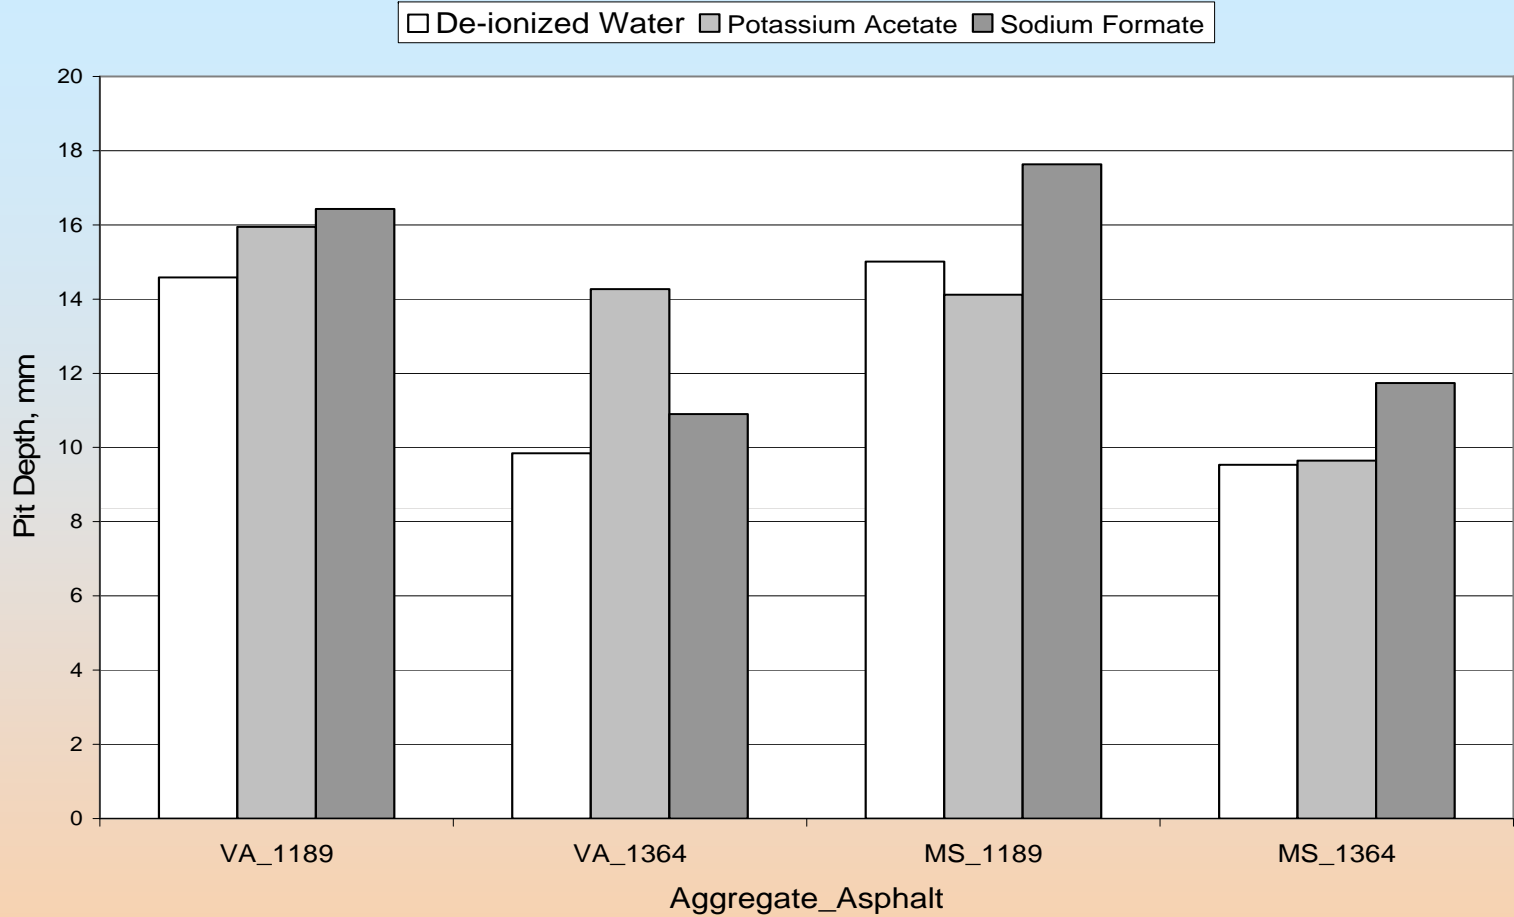
1189 = PG58-28; 1364 = PG64-22 VA = Diabase, MS = Gravel

Softer asphalt – greater pitting

NaOf potentially more aggressive

Inconclusive due to low deicer concentration and horn pitting

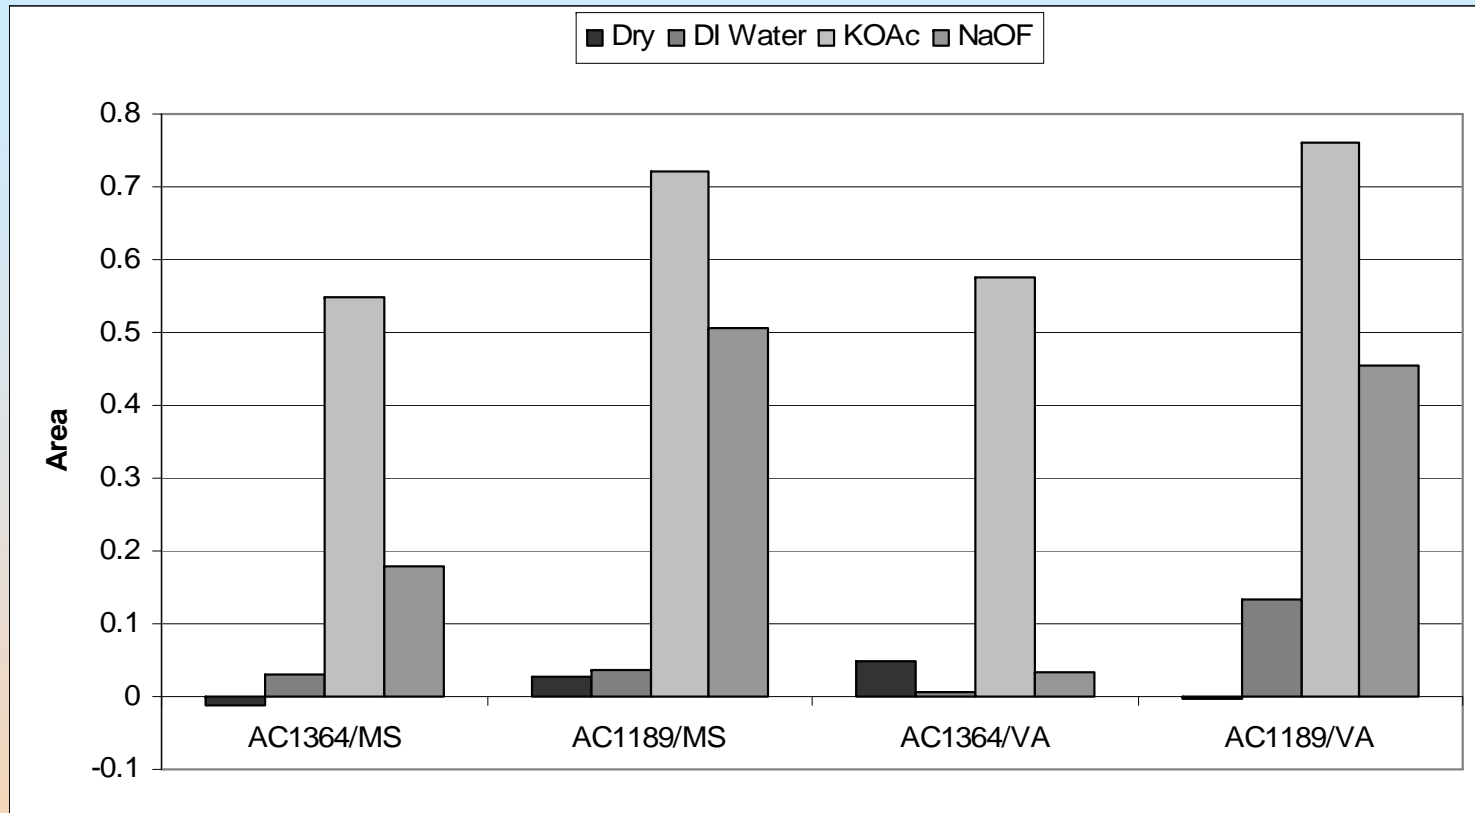
- A chemical flag for deicer damage
- FTIR functional group analysis for carboxylate salt concentrations.
- PAV for 96 hours at 20 atm and 60C
 - Dry Briquette
 - Vacuum Saturated with: deionized H₂O, 2% and 35% KOAc and NaOf
- Extraction in Toluene/EtOH, IR in THF

- 2% solutions appear to have good correlation except NaOf
- Potential flag!

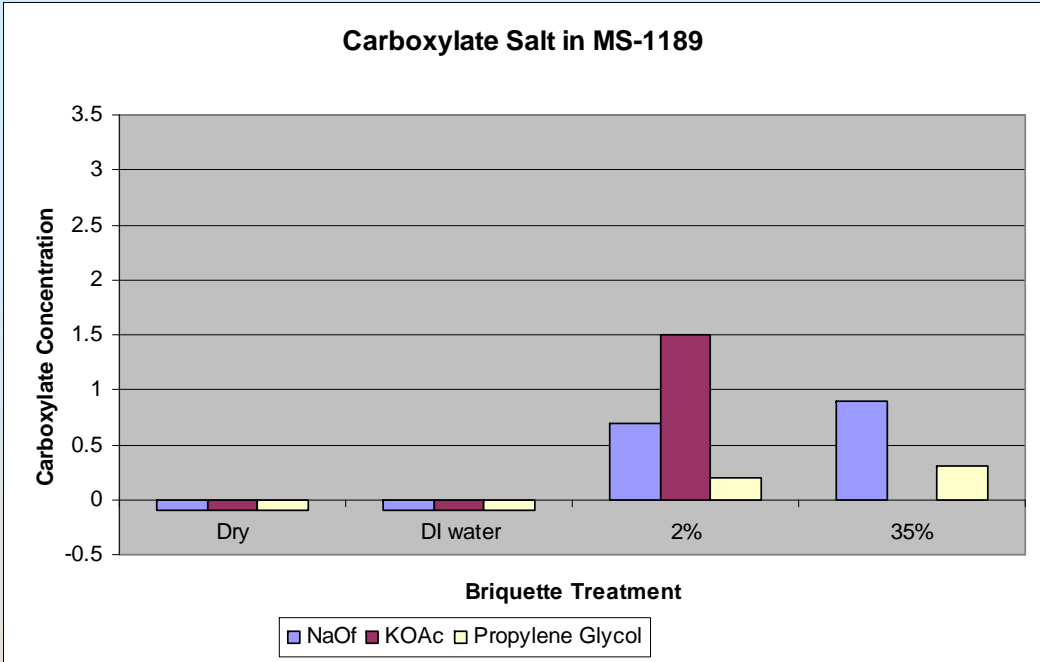
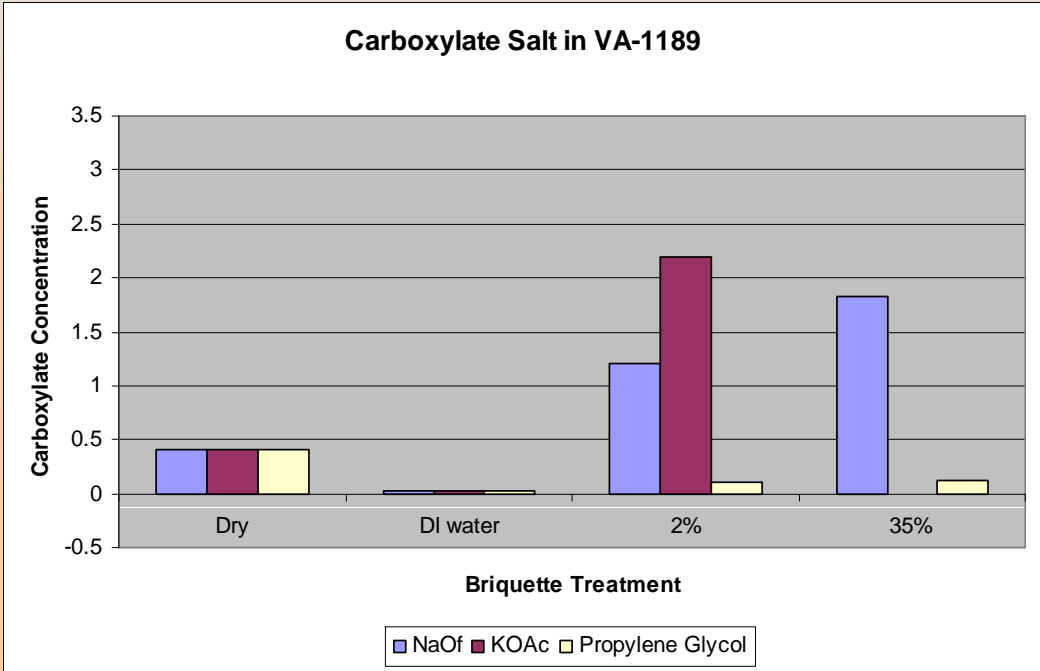
- Huge variation in salt concentration

- Formates more soluble in EtOH than Acetates

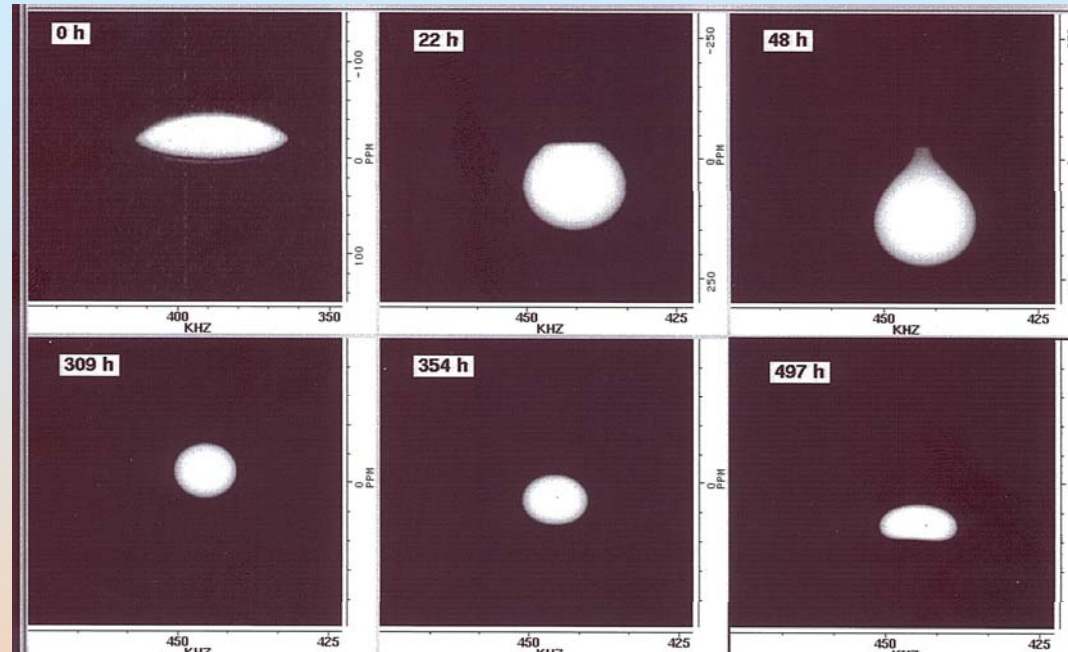
- 35% KOAc, AC 1189
- Decreased interfacial surface tension
- Increased solution density vs water
- Not observed for lower concentration deicers
