2005 Pavement Performance Prediction  
Symposium

Adhesion and Cohesion of  
Asphalt in Pavement

# STPD-43-2(106)

NE Highway #43

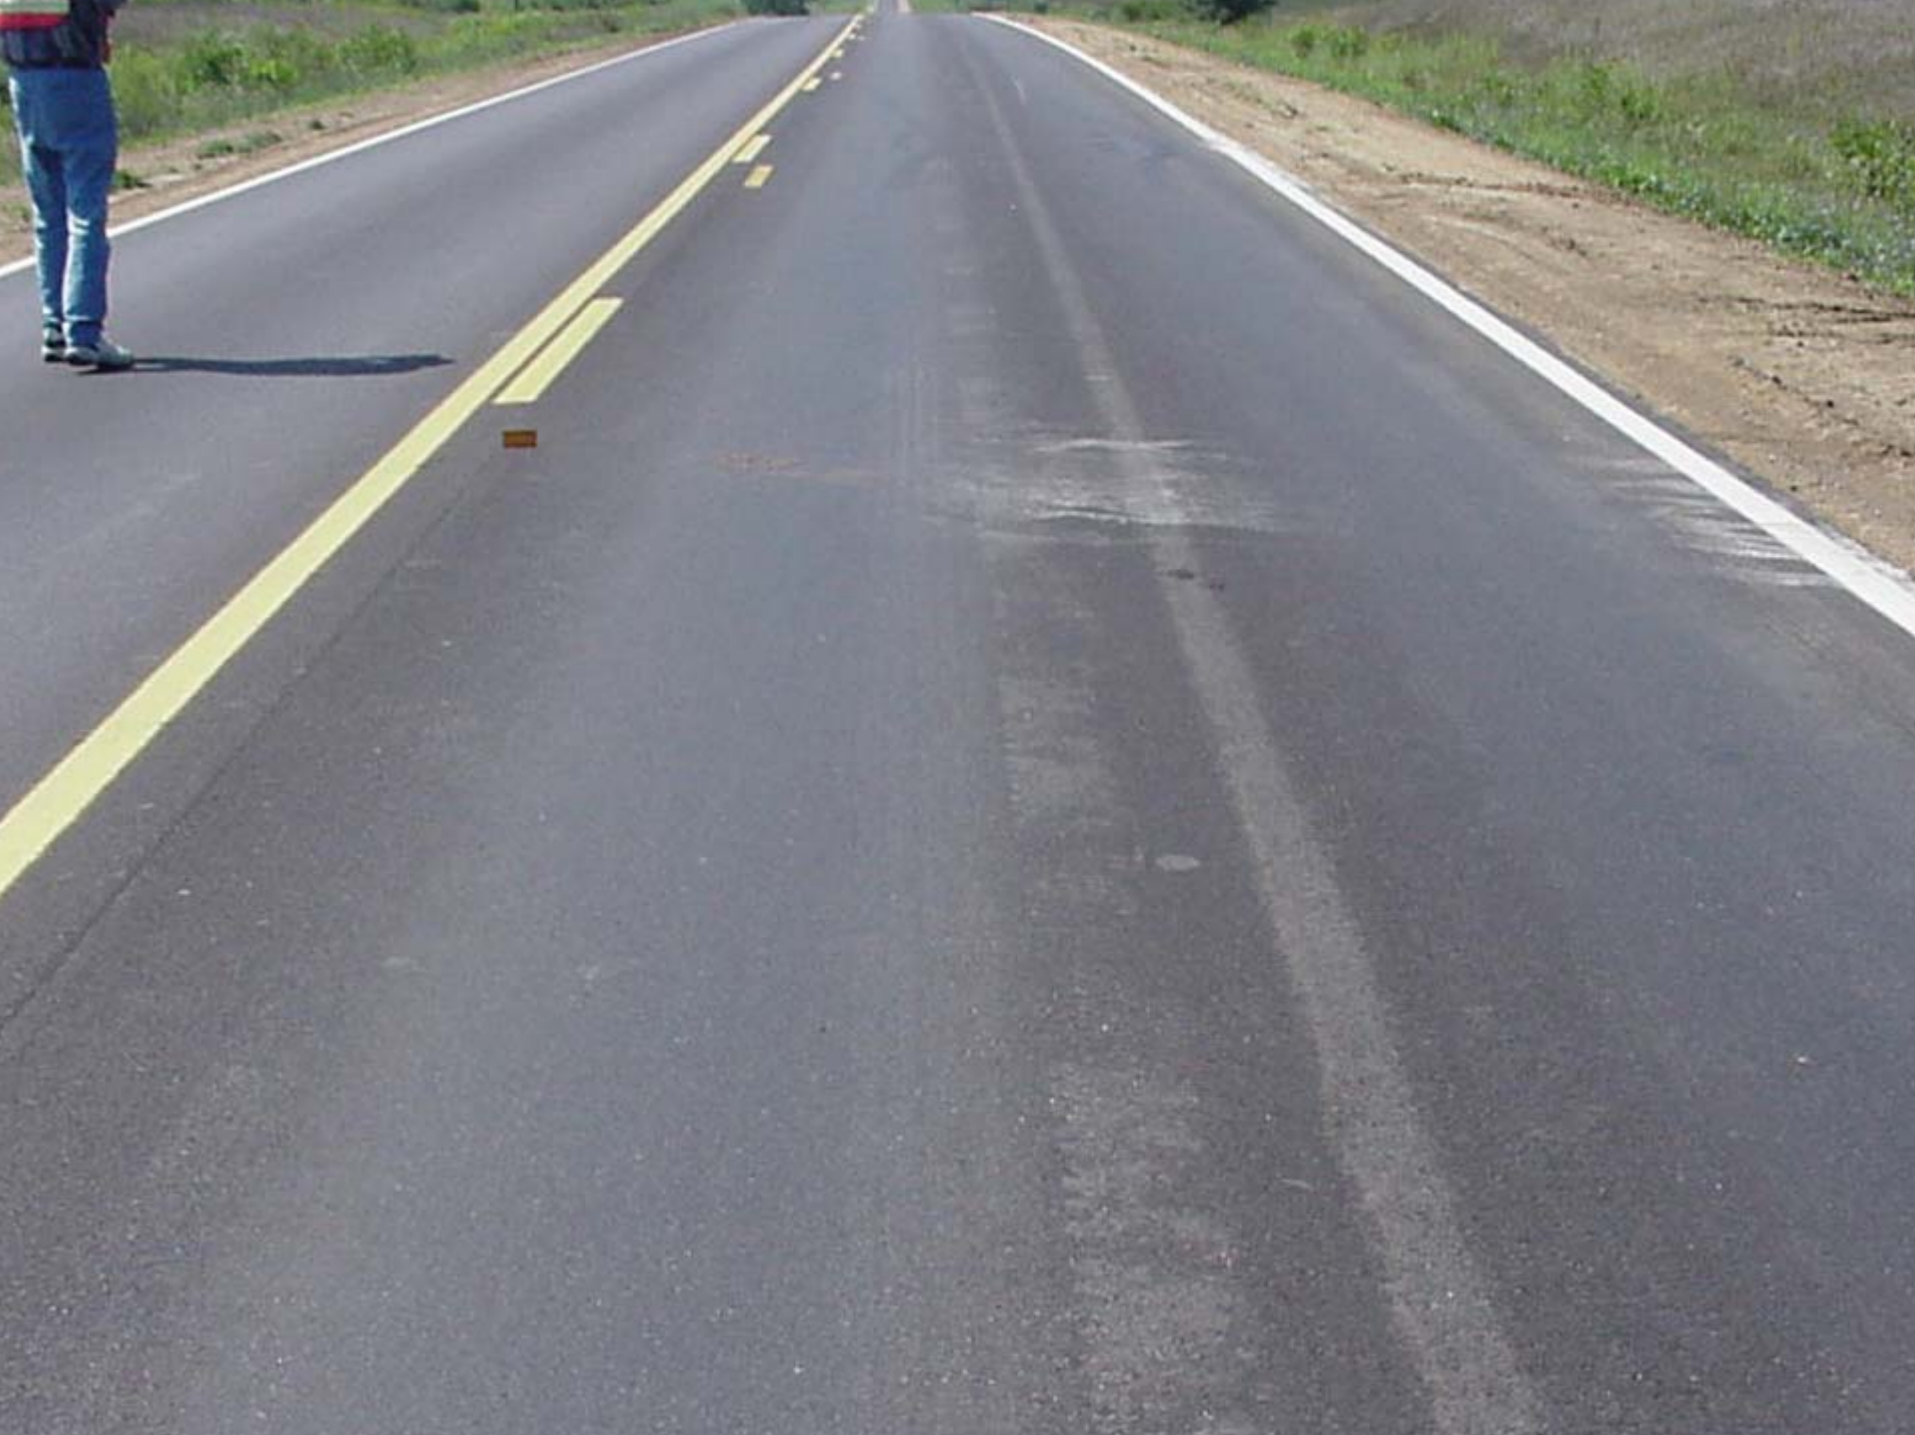
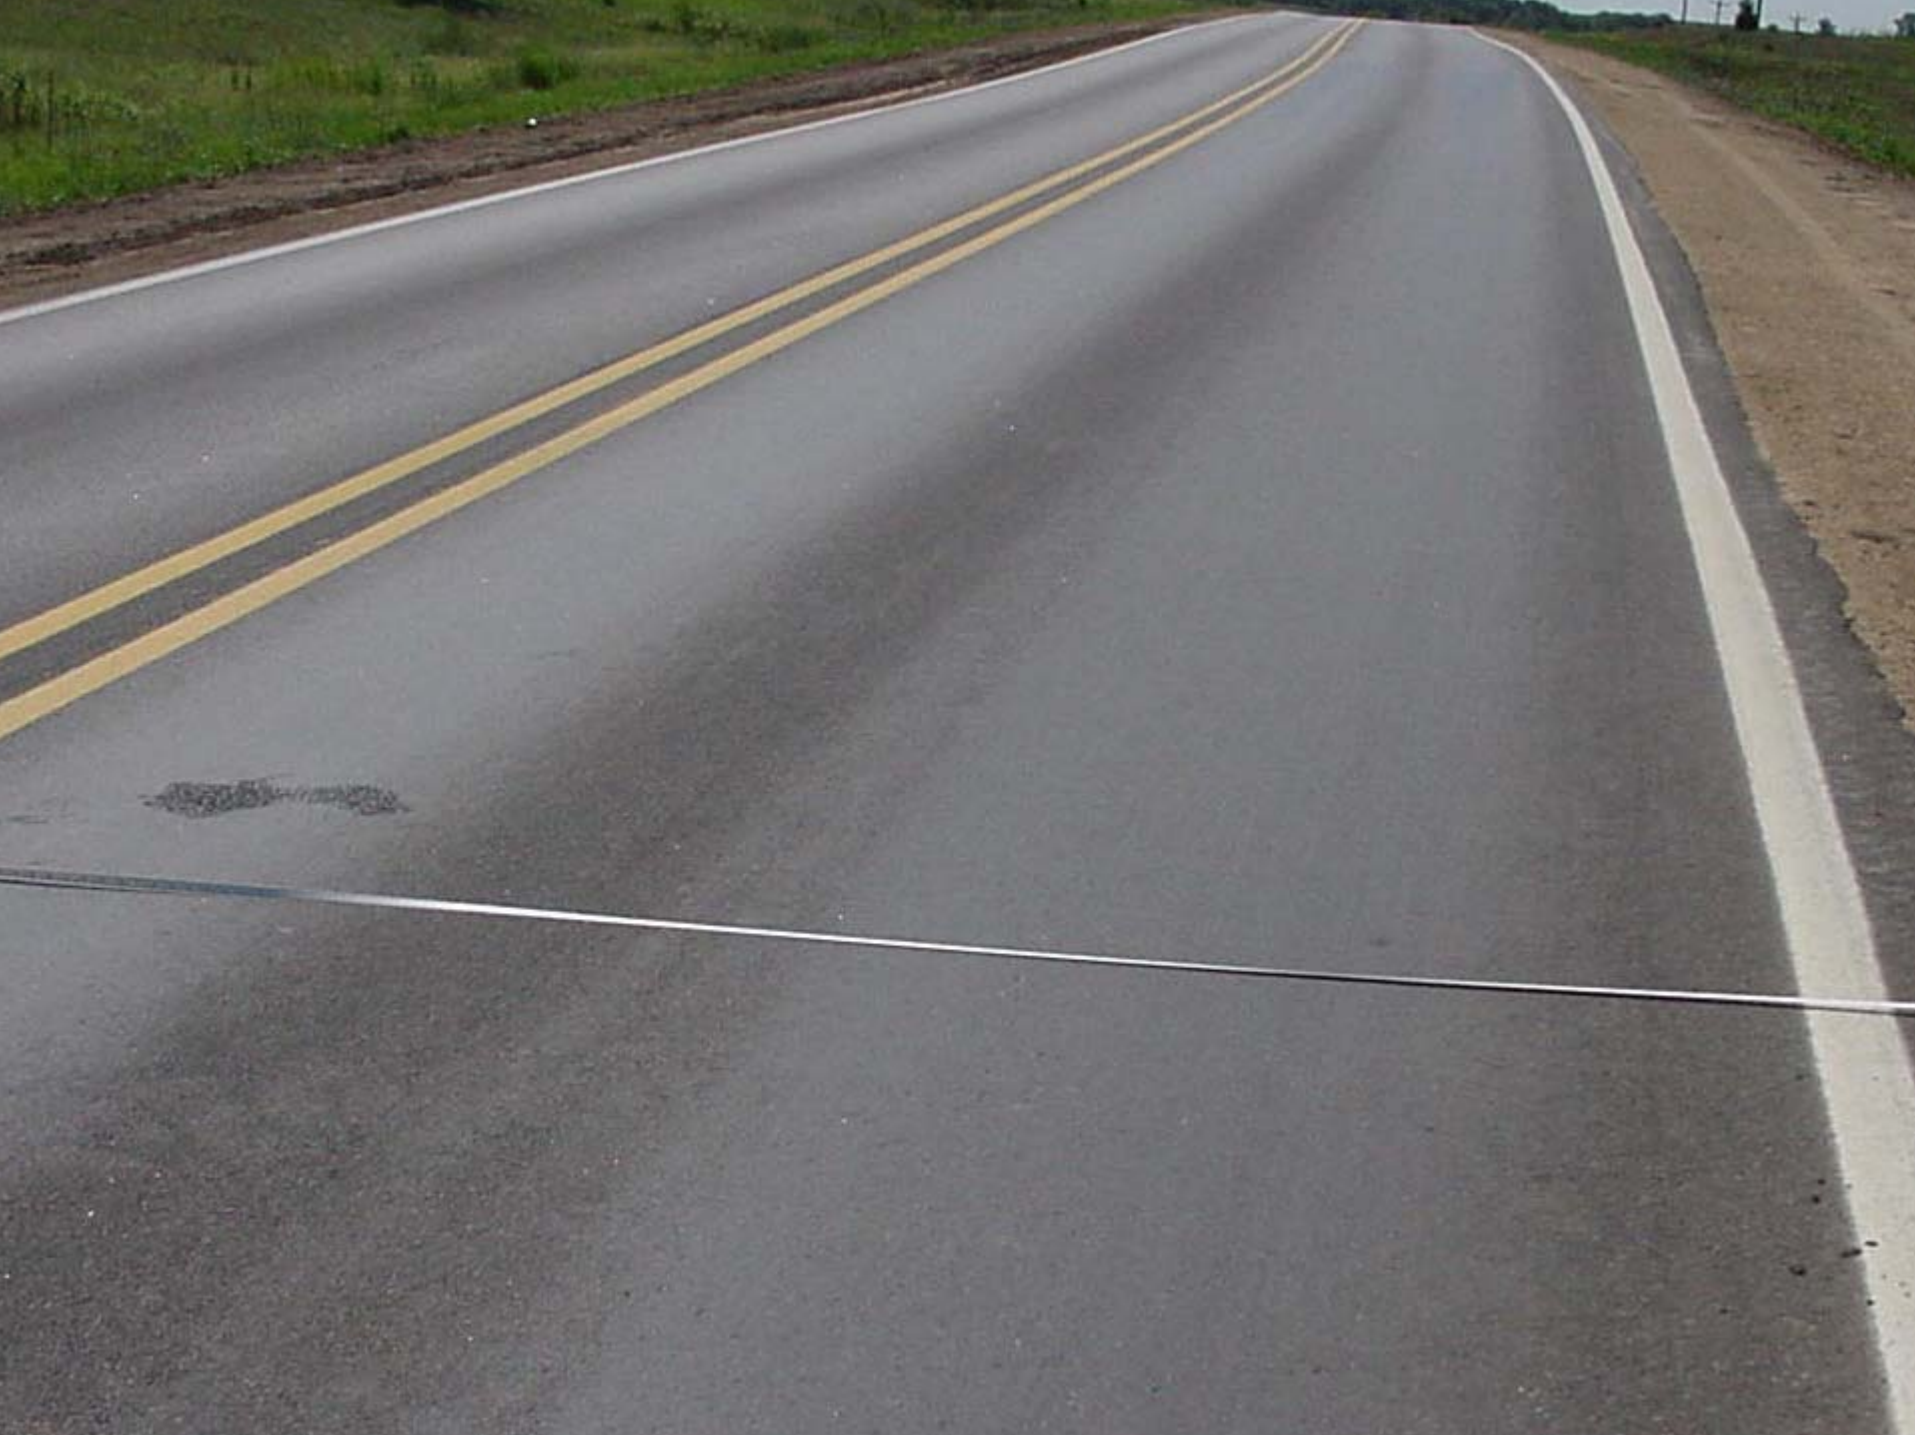
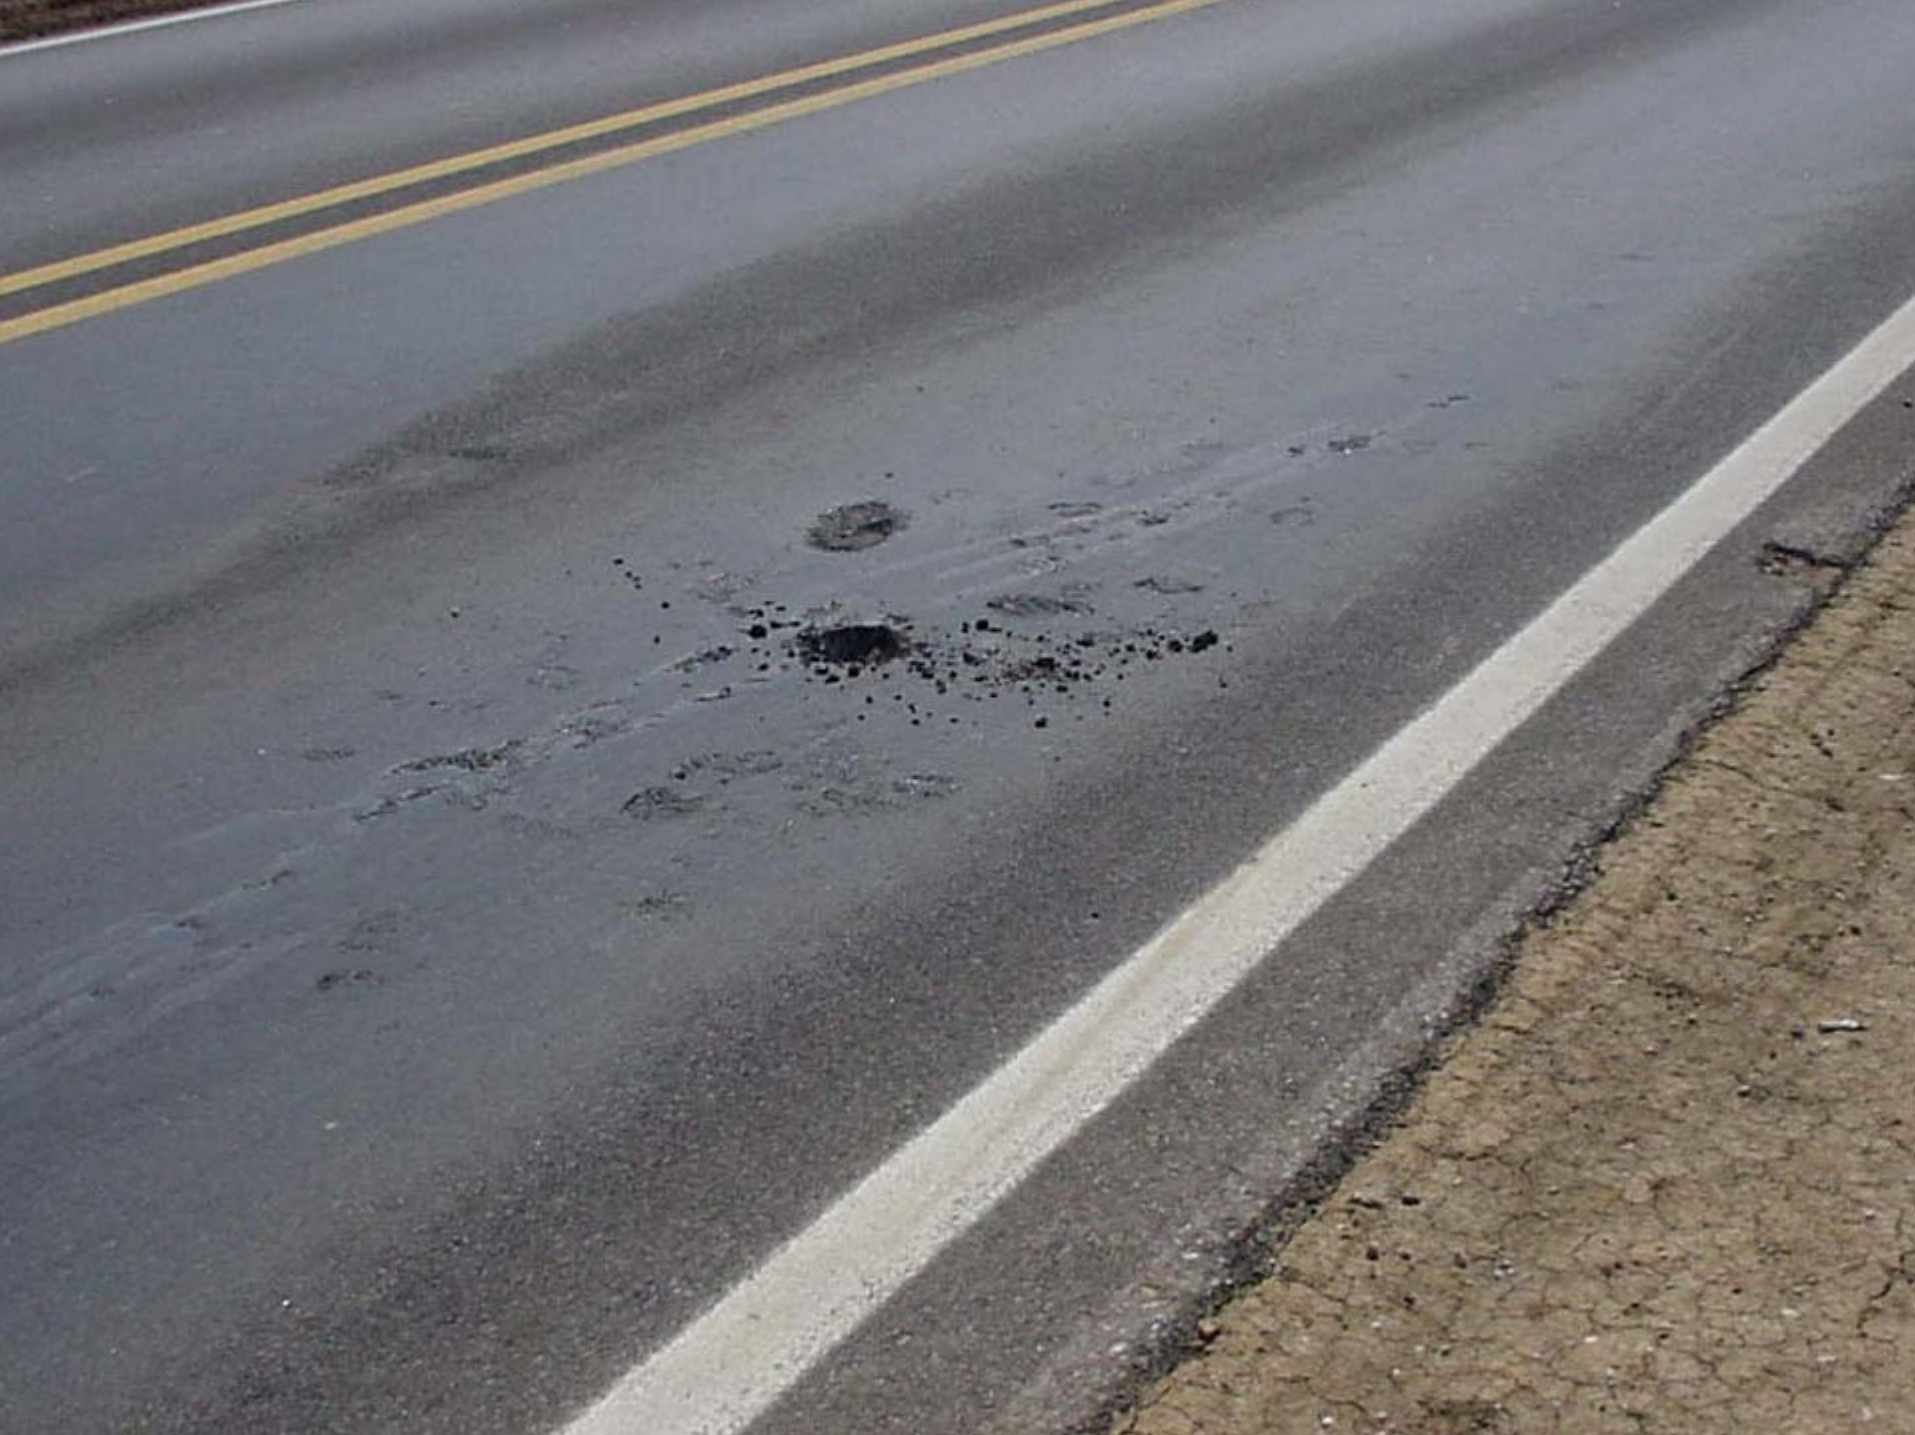
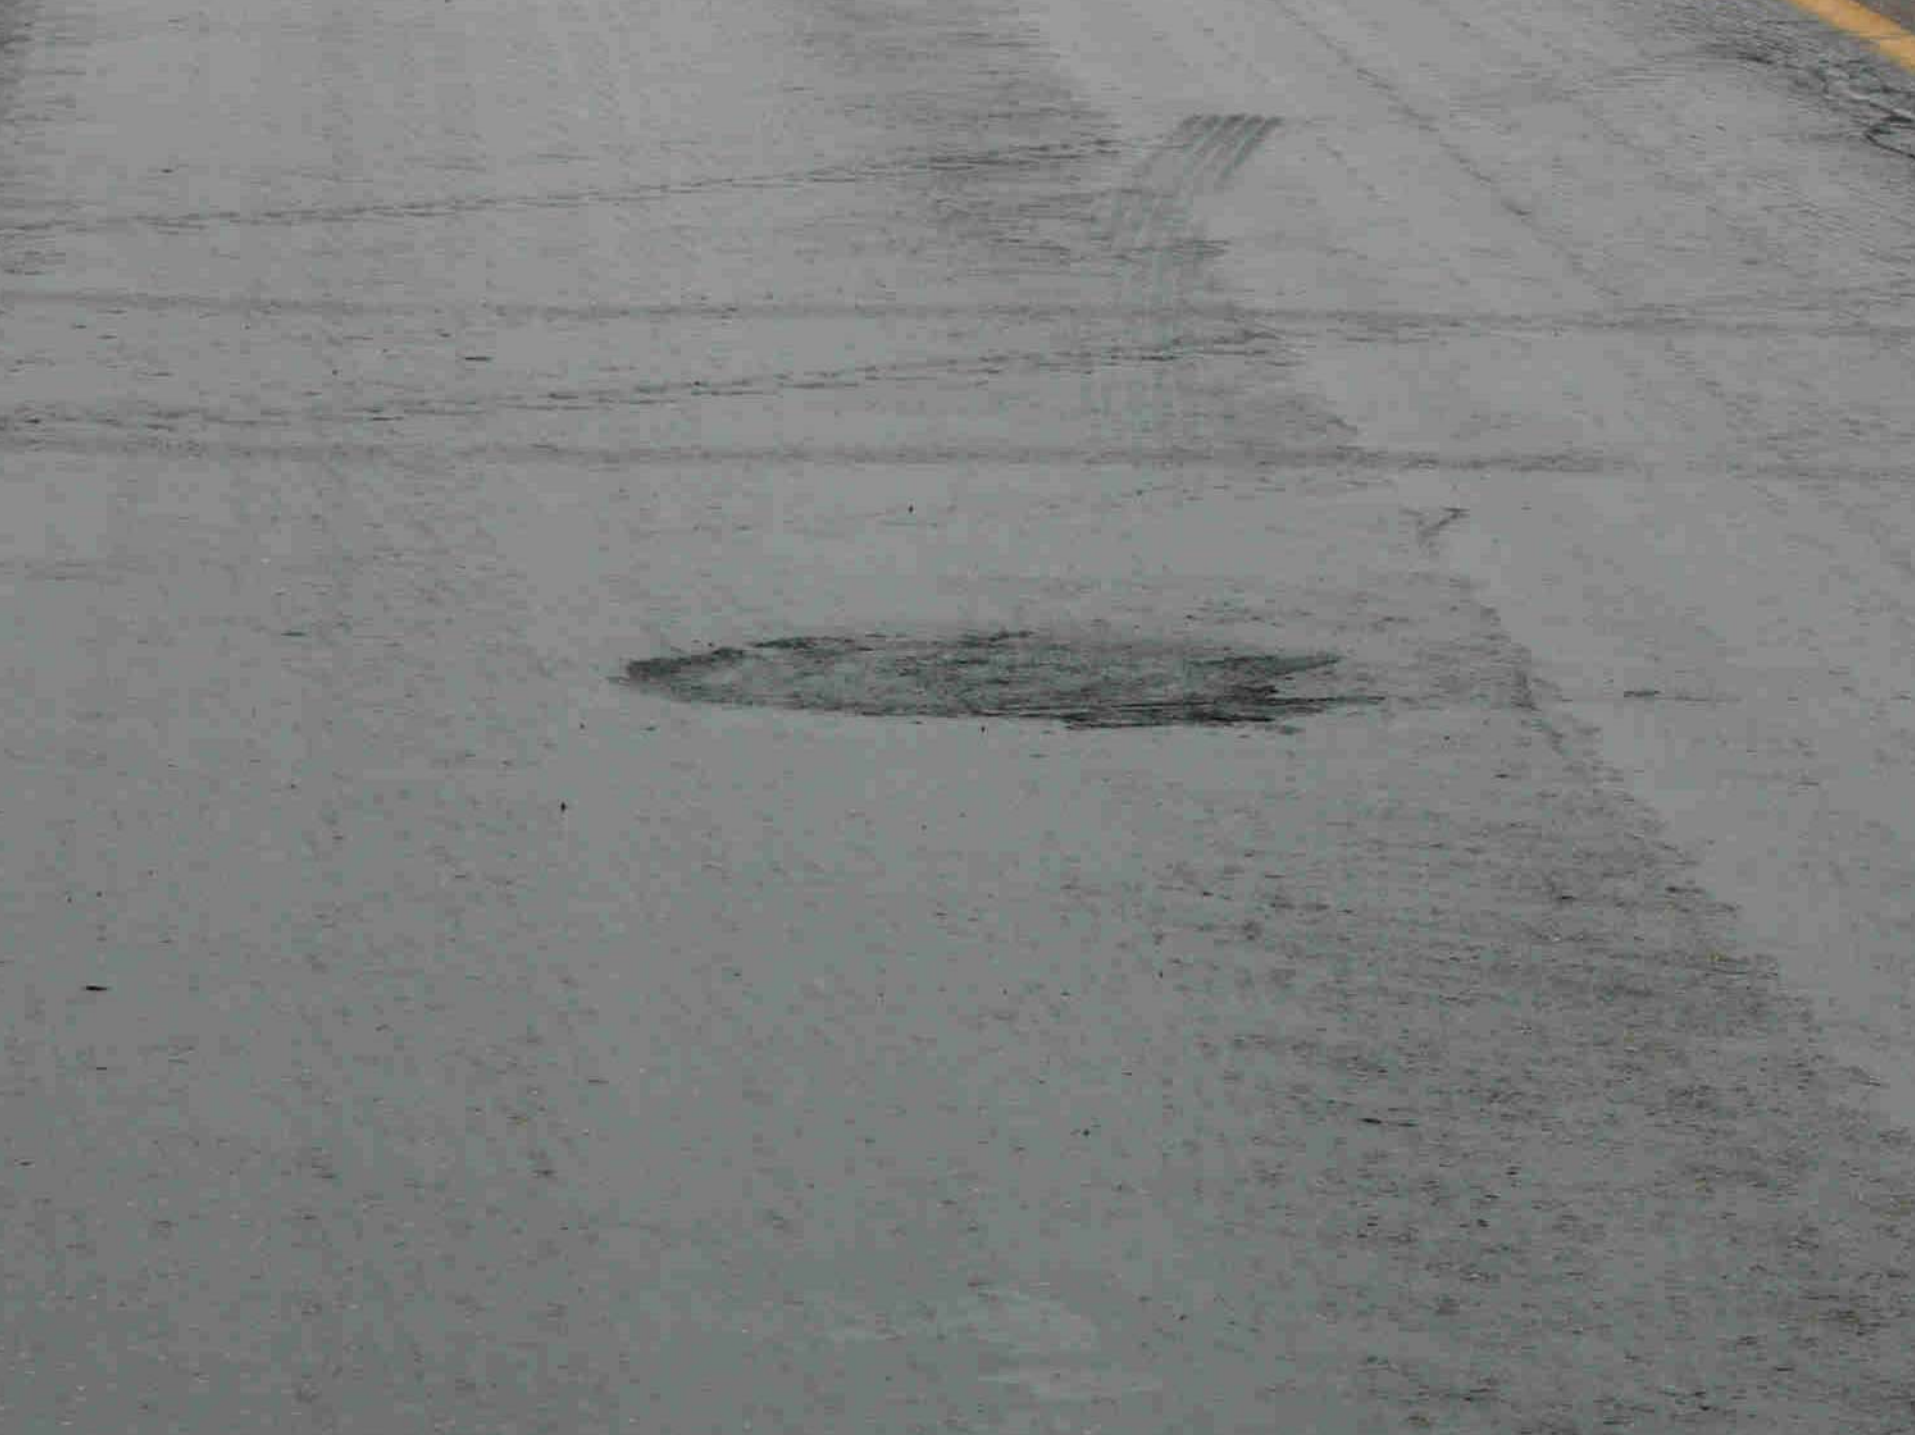
# Pictures of Hwy 43

Calls are coming in to our office asking us to come out and watch the project's wheel paths turn dark, as the asphalt is flushing to the surface!!

- Binder content of “flushed core” was 6.99% in the top and 5.03% in the bottom.

- Binder content of “flushed core” was 6.99% in the top and 5.03% in the bottom.
- There was “lower boiling” material in extracted core vs. original binder.

- Binder content of “flushed core” was 6.99% in the top and 5.03% in the bottom.
- There was “lower boiling” material in extracted core vs. original binder.
- Binder in top of flushed core is softer than the original binder below 86°F.

- Binder content of “flushed core” was 6.99% in the top and 5.03% in the bottom.
- There was “lower boiling” material in extracted core vs. original binder.
- Binder in top of flushed core is softer than the original binder below 86°F.
- More small molecular size material in top of flushed core than in original binder.

We cold milled ½” of the surface off of Hwy 43 and to date the surface has not flushed again.

We applied a 1” OGFC on a 3 mile segment for test and evaluation in 2002. It is performing as expected.
